The following note applies to RX bridges in general, and in particular to the 340 S/N series due to small PCB tolerance errors.

21-Nov-2012

VK3AQZKITS

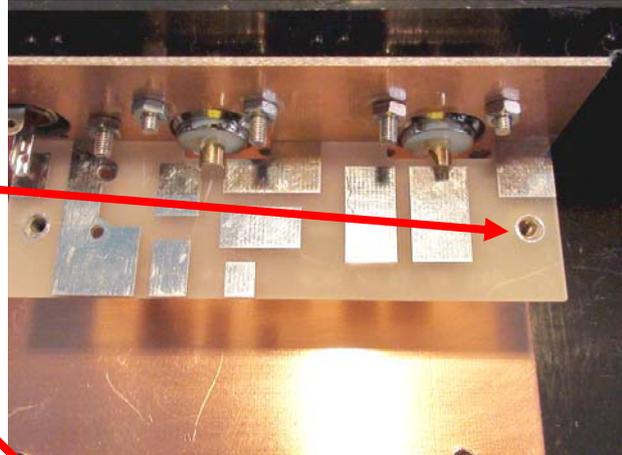
This photo shows that the RF deck holes do not line up with the support pillars.

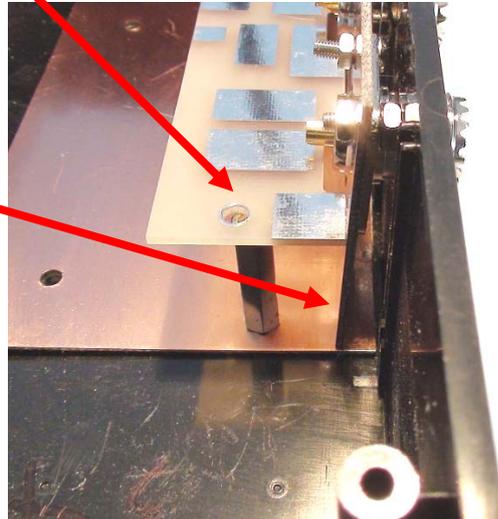
This photo shows a side view of the rear PCB which is not quite vertical. The mounting nuts were pulled up firmly enough but the bottom of the rear PCB had not been pushed up against the case causing the small deviation from vertical. This results in the RF deck holes appearing to not line up. This possibly been caused by the base PCB not been tightened down fully by the pillar mounting screws and therefore curling up and obstructing the bottom of the rear PCB.

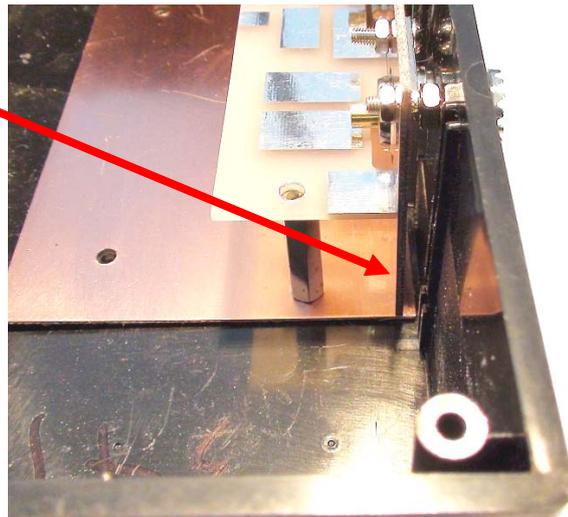
This photo shows the rear PCB pushed at the bottom correctly resulting in a vertical PCB. In this case the holes in the RF deck are better aligned with the pillars. The reason for pointing this out is that during assembly, you may choose to solder the bottom of the rear PCB to the base PCB without realizing the rear PCB is not exactly vertical. Once the 2 PCBs are soldered together, the RF deck holes will not line up. In the event of this happening, loosen the bottom screws in the pillars slightly to allow the top of the pillars to align with the RF deck holes. Then after inserting the RF deck top screws, tighten up the screws in the bottom of the pillar. The pillars may go slightly out of vertical but that will not matter. Small tolerance errors in hole locations can worsen the situation as is the case with some of the RF deck PCBs in the 340 serial number range.

Alternatively, you can try to re-solder the bottom of the rear PCB whilst pushing it back into a vertical position. However that can sometimes be easier said than done without making a bit of a mess.
